# Denture initiated periimplantitis – a problem in implant dentures

Findings from 25 years of manufacturing dentures

WOLFGANG BOLLACK, MARIUS STEIGMANN

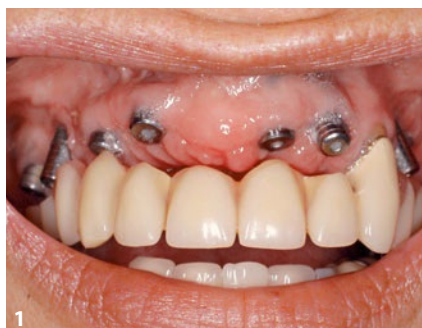
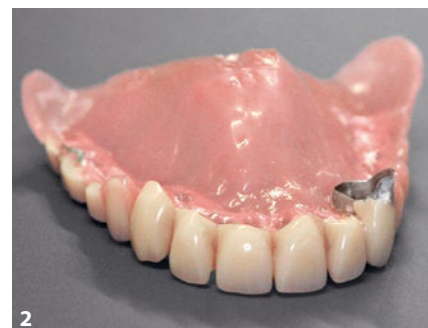
**Fig. 1** Initial situation. **Fig. 2** Old denture.

The first case presented here relates to the patient's wish for a secure denture on implants. She previously wore a telescopic restoration, where all of the teeth had been lost apart from one, whereby significant bone loss occurred (fig. 1 to 7).

In image 1, it is clearly visible how big the vertical gap between the implant exit point and the incisal edges of the anterior maxilla was. To resolve this situation somewhat aesthetically, it was necessary to burn gingiva from ceramic.

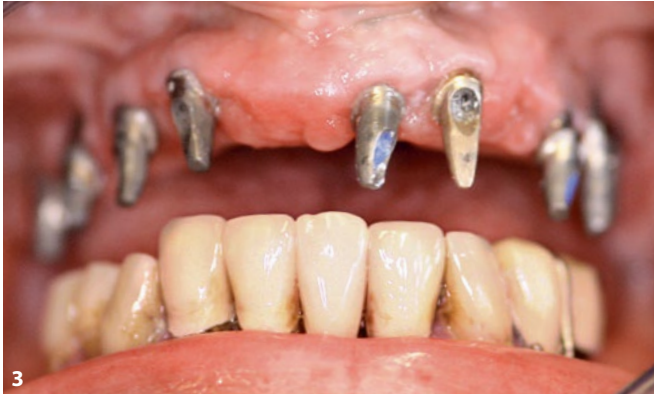
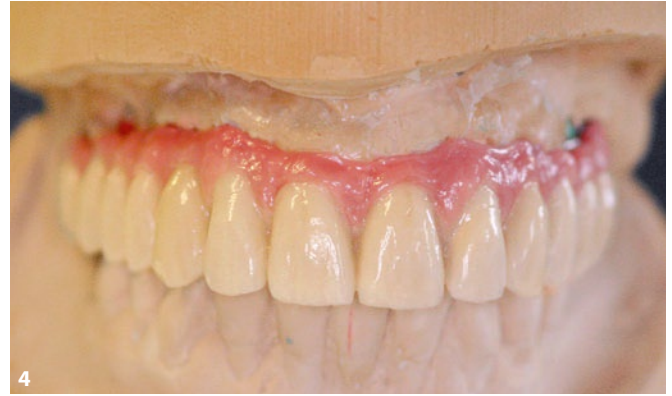
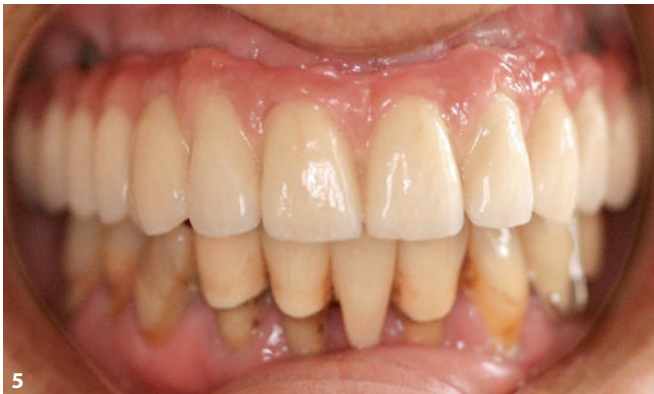
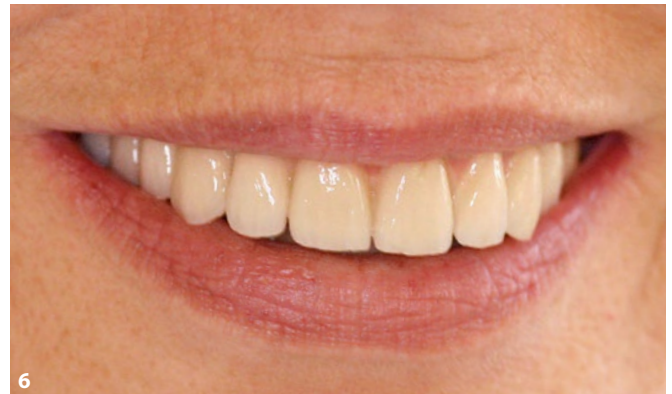
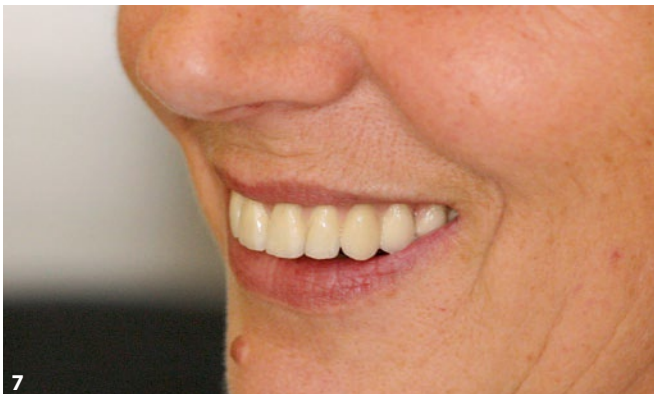
**Fig. 3** Abutment situation in the mouth. **Fig. 4** Pink ceramic design on the model. **Fig. 5** Transition from pink ceramic to mucous membrane. **Fig. 6 and 7** The aesthetic situation in the mouth.

In the maxilla there is the problem that it is not always possible to manufacture sufficiently large cleaning channels in the implant positions, because otherwise patients spit through the holes, and are impeded in articulation. This was also

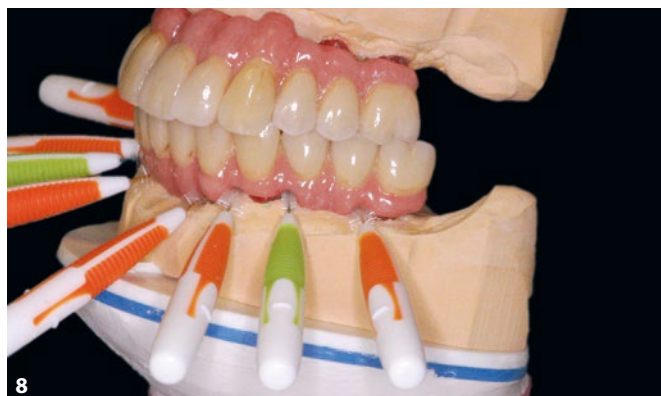
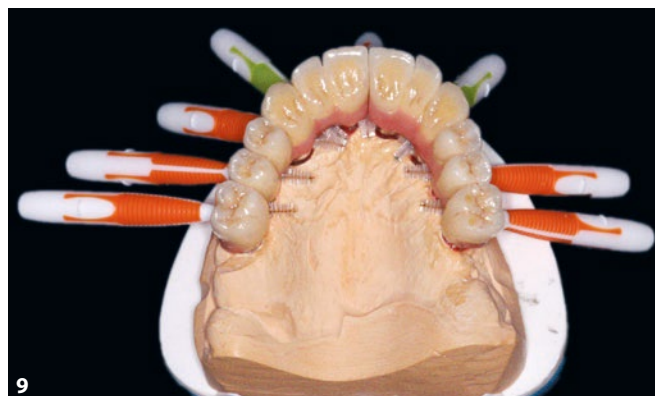
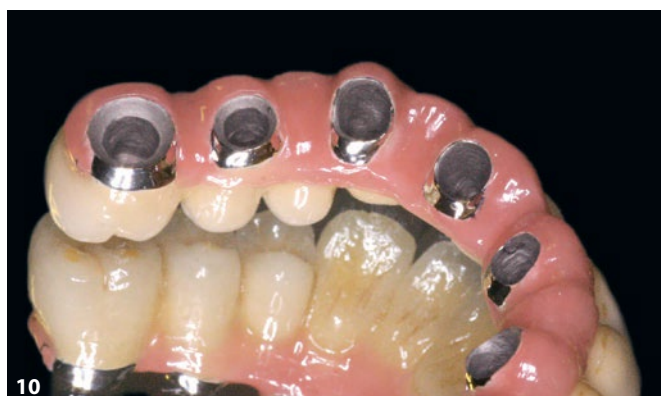
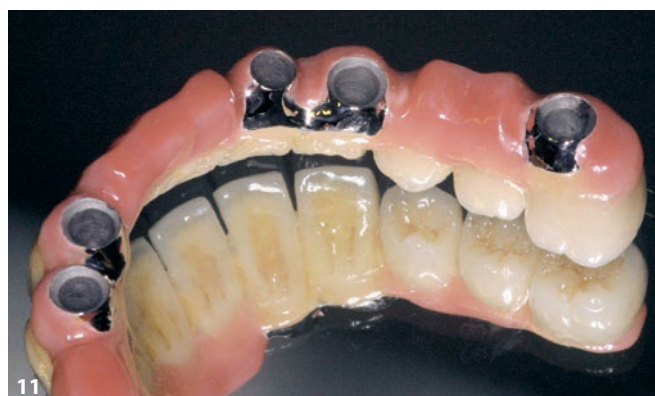
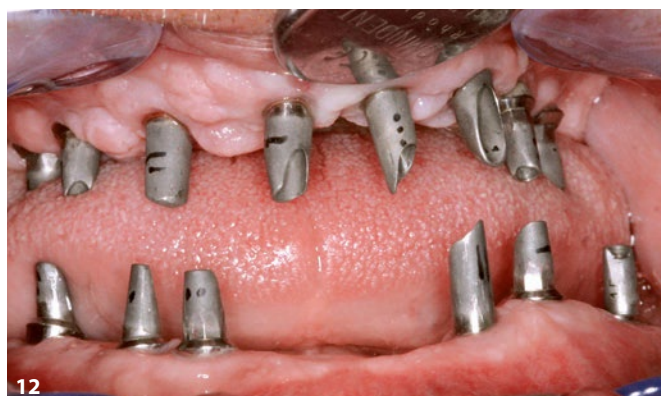
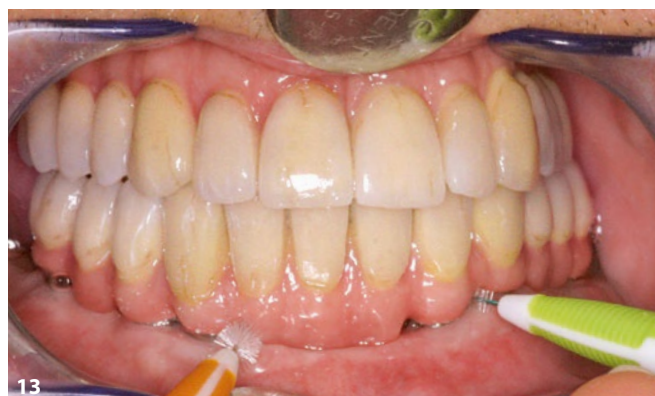
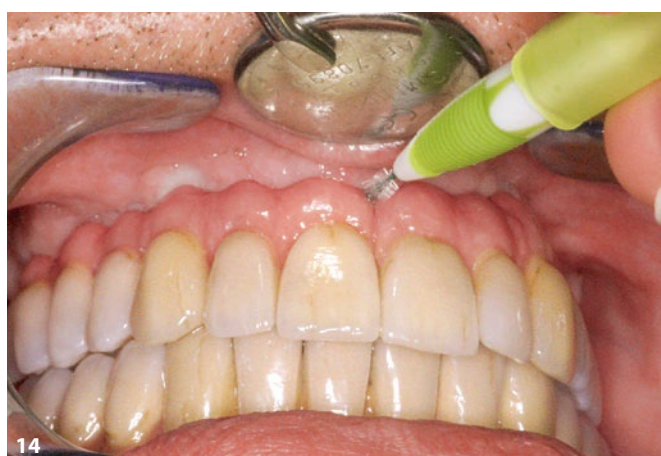
**Fig. 8 and 9** Cleaning channels are inspected in the laboratory.  
**Fig. 10 and 11** Good basic design for fixed denture.  
**Fig. 12** Abutment situation in the mouth.  
**Fig. 13 and 14** Inspection of the cleaning channels in the mouth.

conditions for cleanability, the following basic design is necessary: all contact surfaces with the gingiva should be convex and high-gloss attached and/or polished. The size of the cleaning channels is checked in the laboratory, and again in the practice. Until now, there have been no notifications of periimplantitis in this case. As older patients become a little lax with cleaning, are

often manually impeded, and in care homes the fixed restorations can no longer be reliably cleaned, removable restorations become obligatory from this point (fig. 8 to 14).

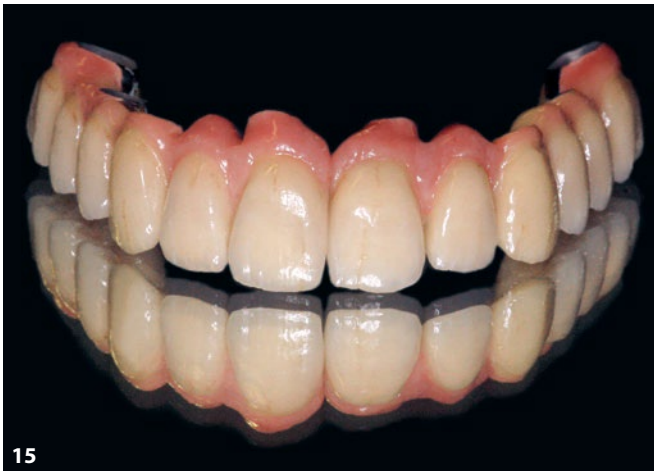
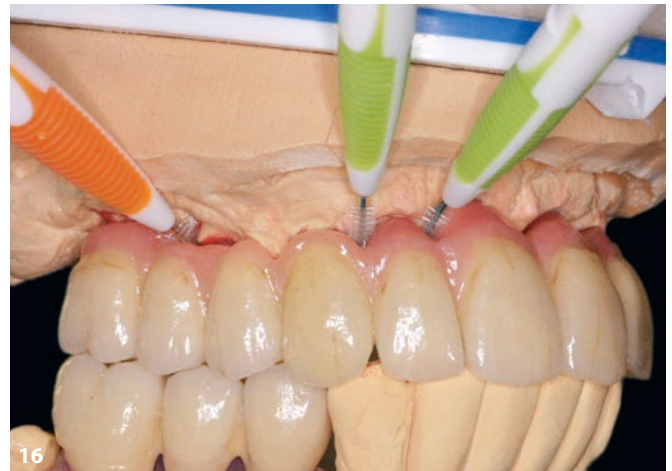
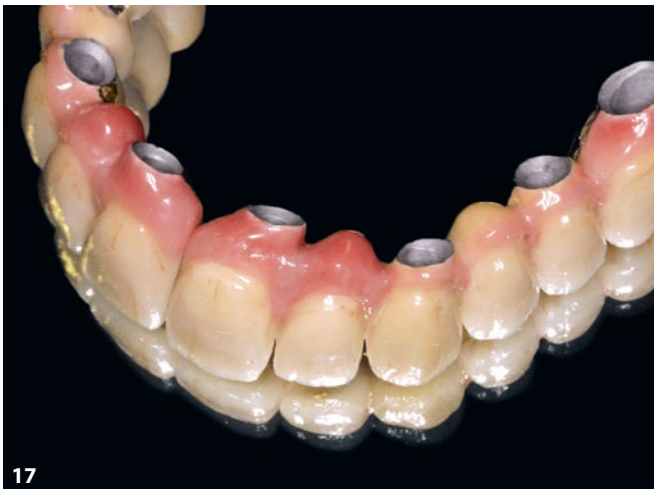
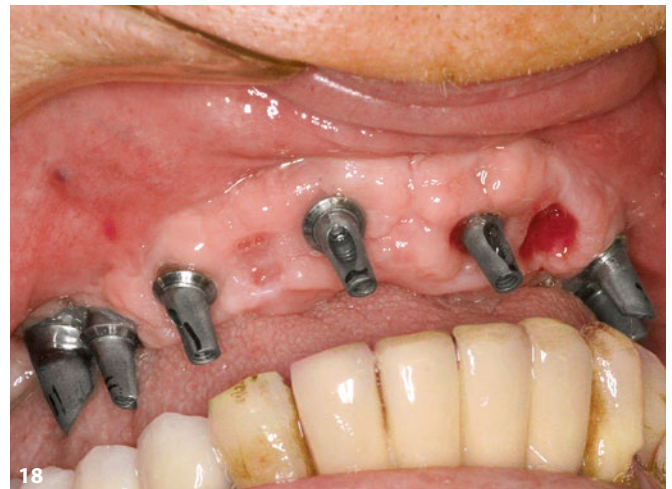
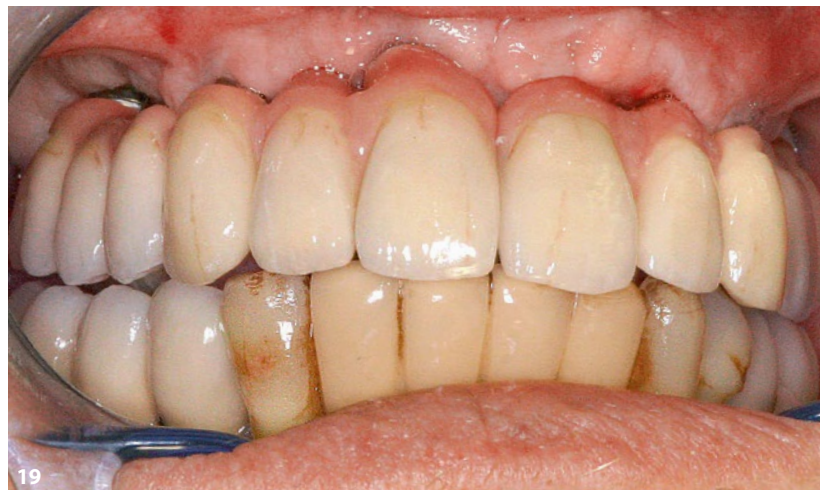
**Fig. 15** The bridge design. **Fig. 16** Inspection of the cleaning channels on the model. **Fig. 17** Bridge design on the gingiva. **Fig. 18** Abutment situation in the mouth. **Fig. 19** Inserted bridge with sufficient space for cleaning.

After just five years, periimplantitis occurred, and the patient lost two implants. The rest were able to be saved. He now wears a removable galvano work (fig. 15 to 21).

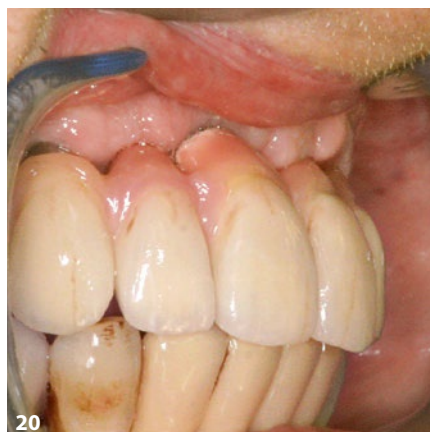
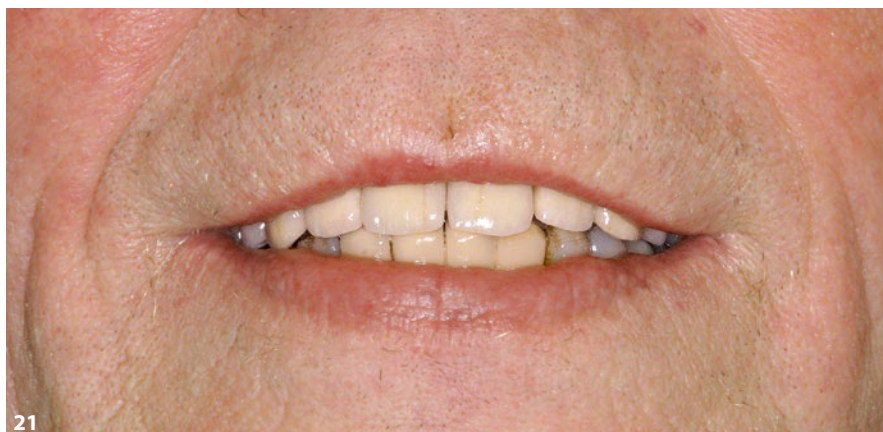
**Fig. 20 and 21** The aesthetic situation in the mouth.

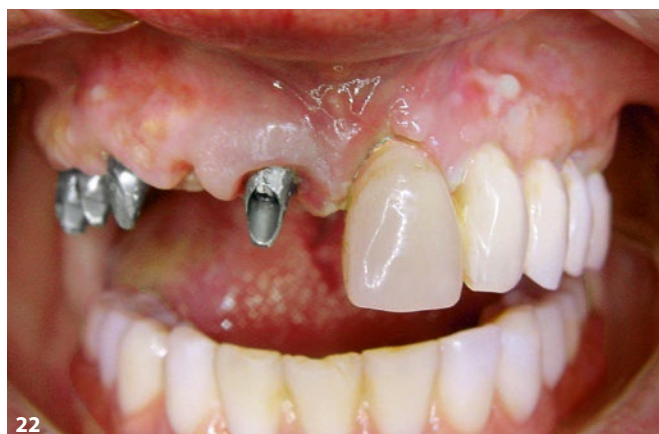
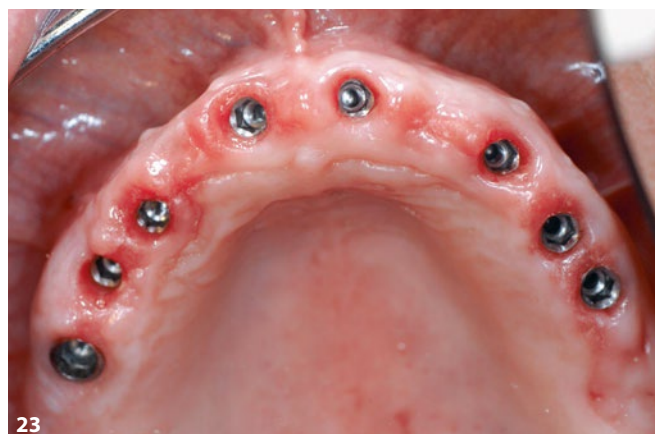
**Fig. 22** Temporary implant for the development of the gingiva. **Fig. 23** Gingiva situation at the start of the final restoration.

With full arch restorations for example, the authors always begin with a metal reinforced temporary implant as an immediate restoration, which will be inserted three days after the operation and then stays in the mouth for approx. six to twelve months. The focus here is primarily on gingiva management, but it is also

about the patient having secure teeth as quickly as possible. The final restoration is only started when the gingiva conditions are good.

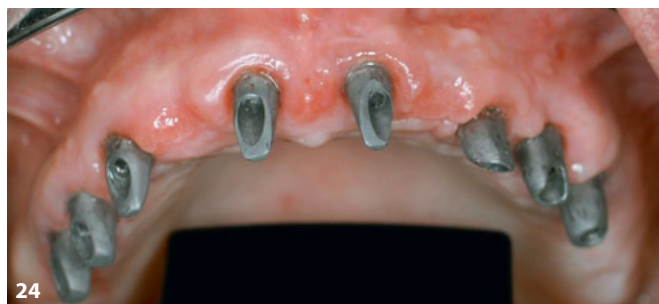
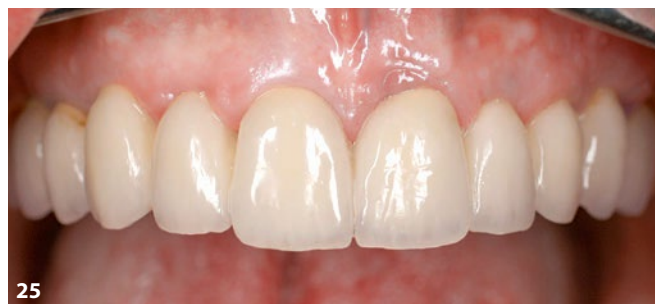
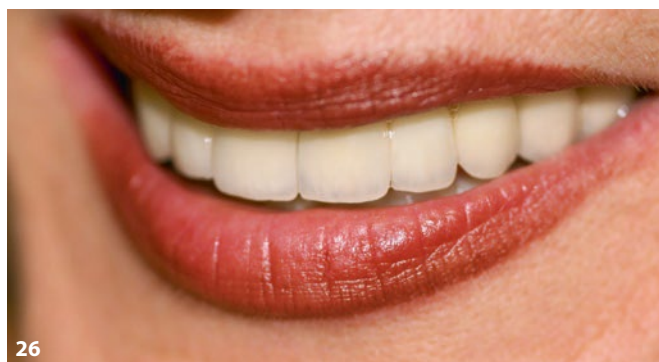
**Fig. 24** Situation of gingiva and abutment. **Fig. 25** Good gingiva with inserted bridges. **Fig. 26** The aesthetic situation in the mouth.

standard can be achieved in this. They have not yet experienced any cases of periimplantitis with these restorations (fig. 22 to 26).

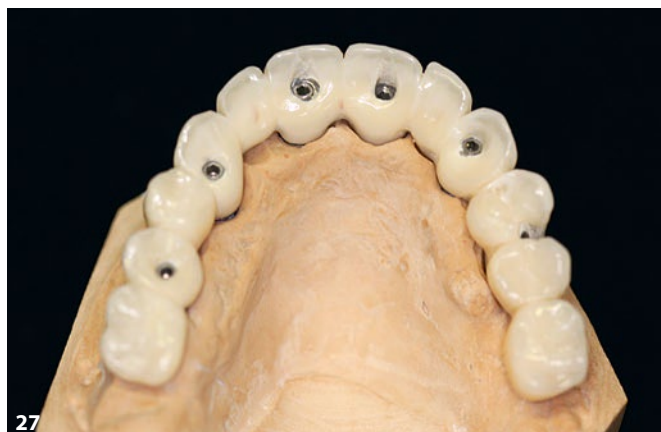
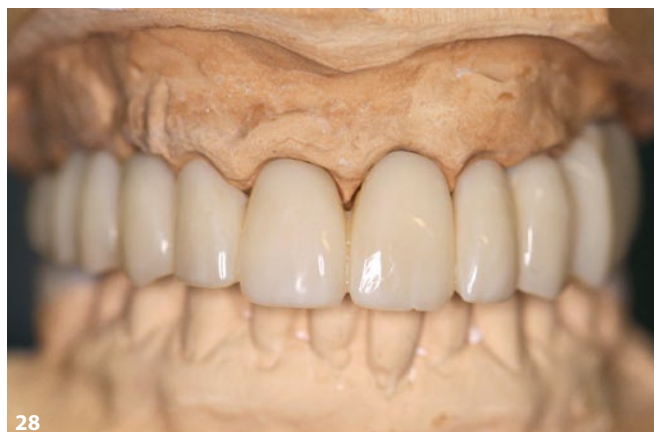
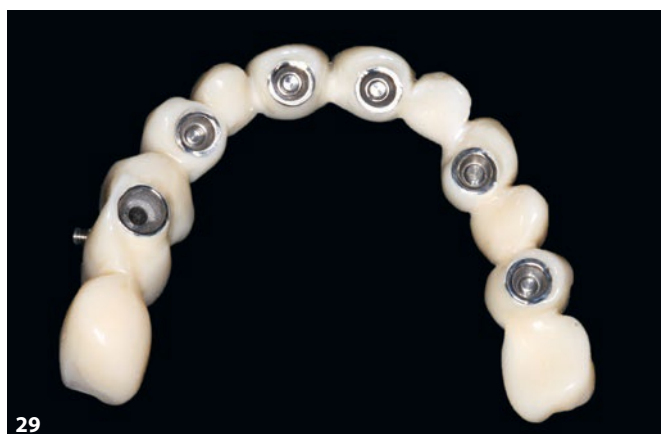
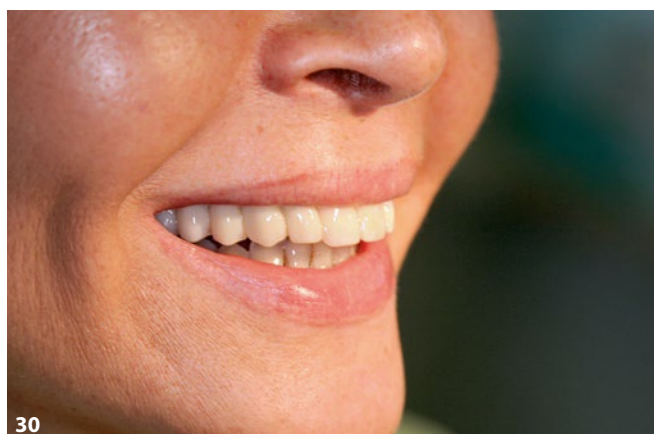
**Fig. 27** Screwed-in bridge. Composite with perfectly fitting screw channels. **Fig. 28** The model situation. **Fig. 29** Bridge design from the basal level. **Fig. 30** The aesthetic situation in the mouth. **Fig. 31 and 32** Significant overhangs over the abutments. **Fig. 33 and 34** Gingiva situation, where the overhangs are below the gingival line.

Screwed-in restorations are frequently chosen, when there are fears with cemented restorations that the screws could loosen, and the cement residues are difficult to remove. Above all with regards to temporary implants for full arch immediate restorations, the authors only choose the screwed variant. Simple, metal reinforced versions are offered as temporary implants, and screwed-in bridges for the final restoration, veneered with high-strength composite. For bimaxillary restorations, a jaw is made from ceramic, with the opposing jaw as a screwed-in composite bridge (fig. 27 to 30).

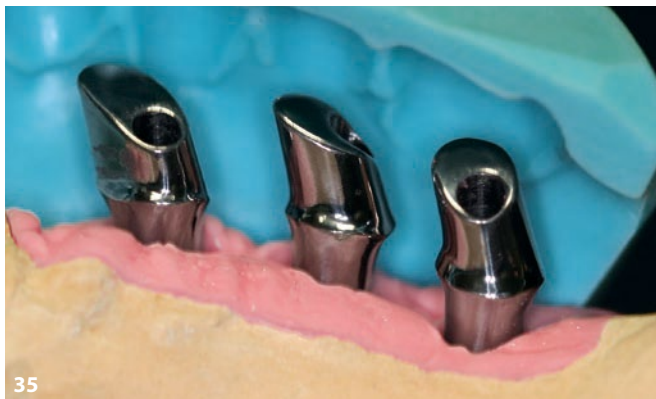
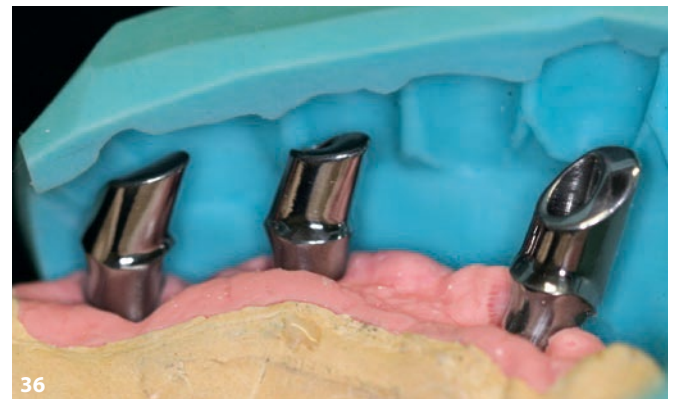
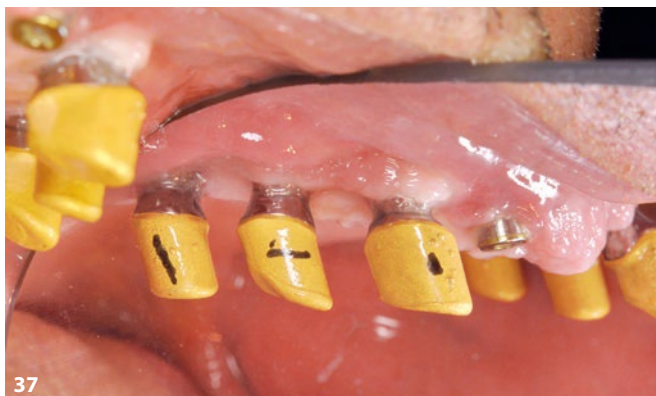
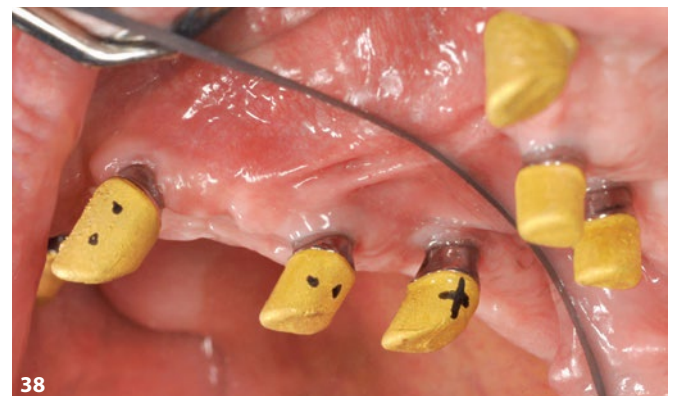
**Fig. 35 and 36** Slimline design of the abutments on the gingival line. **Fig. 37 and 38** Situation in the mouth with galvano copings. **Fig. 39 and 40** Form fitting basic design for removable denture.

To solve this problem, the authors place the abutments "on stilts". Due to the slimline design of the abutments on the gingival line, the restoration is significantly easier to clean. This means that periimplantitis can be prevented (fig. 35 to 38).

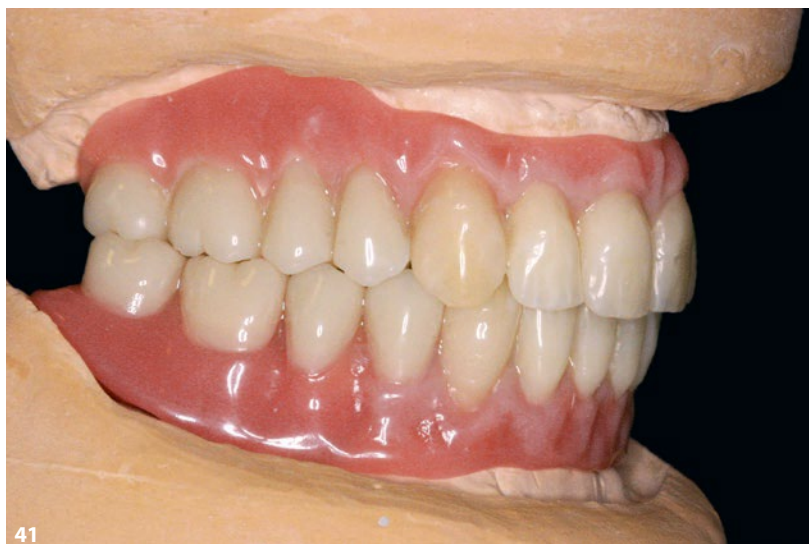
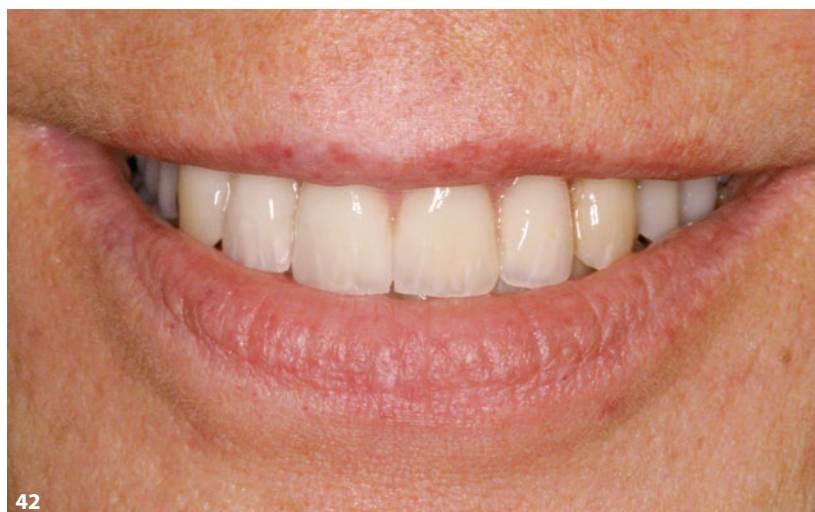
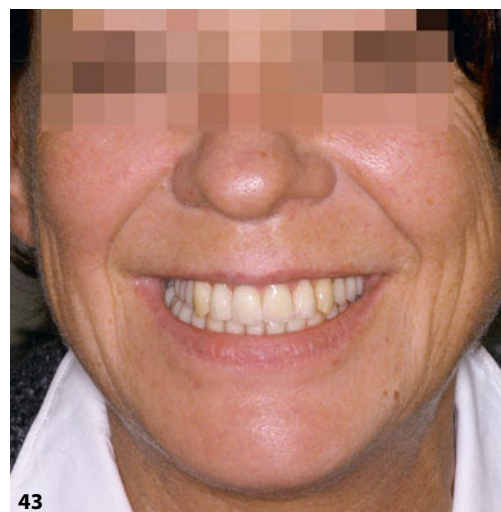
**Fig. 41** Natural colouring in pink plastic. **Fig. 42 and 43** The aesthetic situation in the mouth.

Another big advantage of removable dentures is that the denture base can be adapted to the gingiva very tightly and practically seamlessly. Patients value the wearing comfort and secure hold, and the restoration has a good aesthetic (fig. 39 to 43). Extreme jaw conditions can also be managed well with galvano technology (fig. 44 to 49).

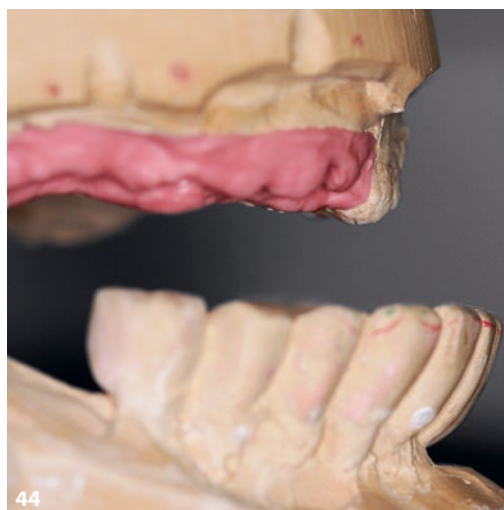
**Fig. 44** Big difference between the maxilla and lower jaw in the horizontal, more than a centimetre had to be bridged over.

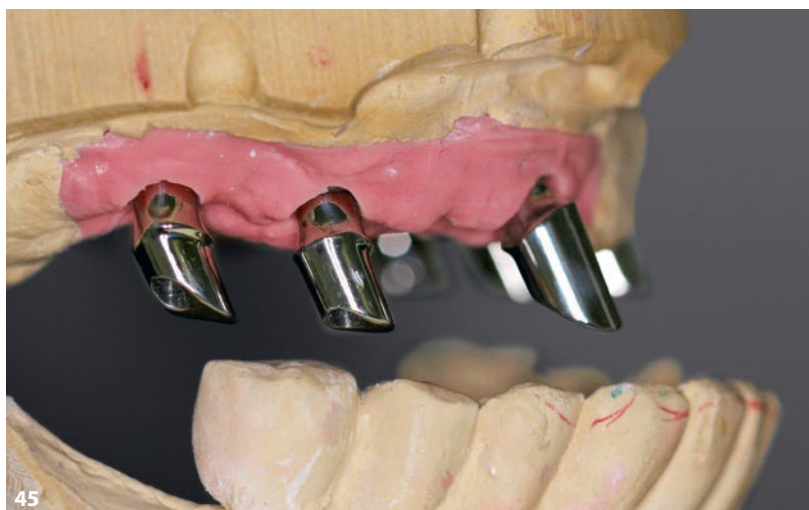
**Fig. 45** Severely frontal facing abutment direction.

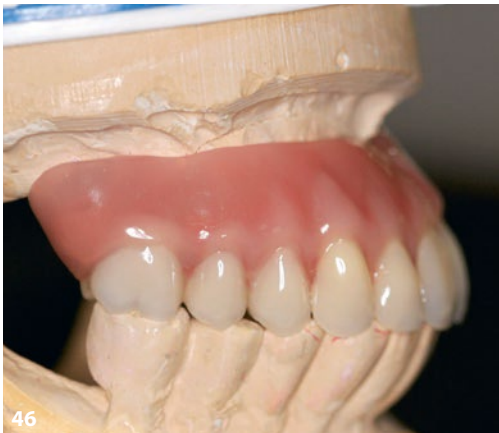
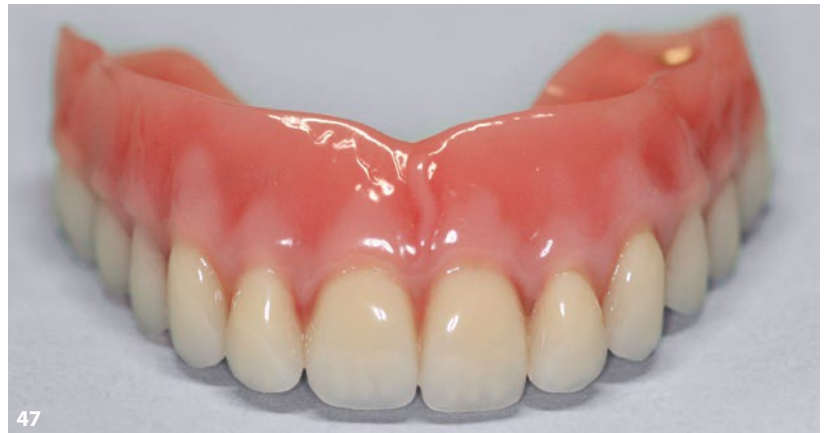
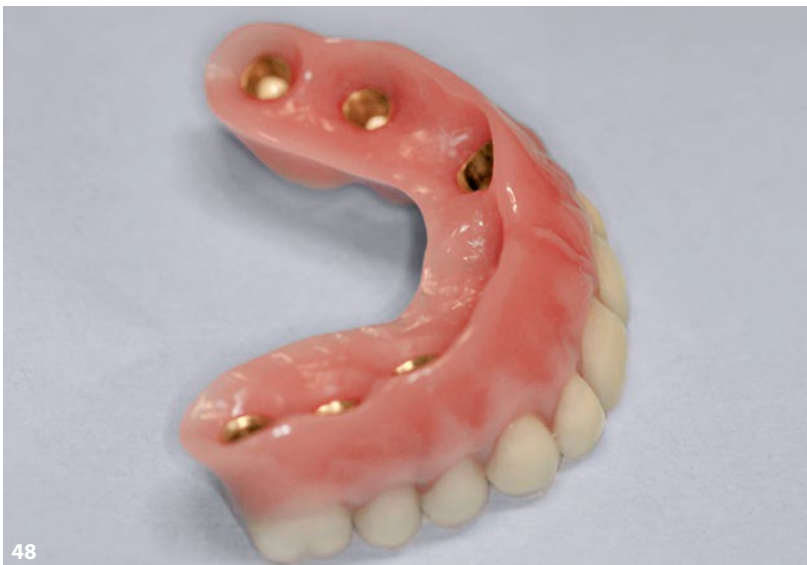
**Fig. 46 to 48** Denture design with individualised pink plastic. **Fig. 49** The smile of the happy patient.
